The Secretary of the Interior's Standards
for the Treatment of Historic Properties

with Guidelines for
Preserving, Rehabilitating
Restoring & Reconstructing
Historic Buildings

Kay D. Weeks and Anne E. Grimmer

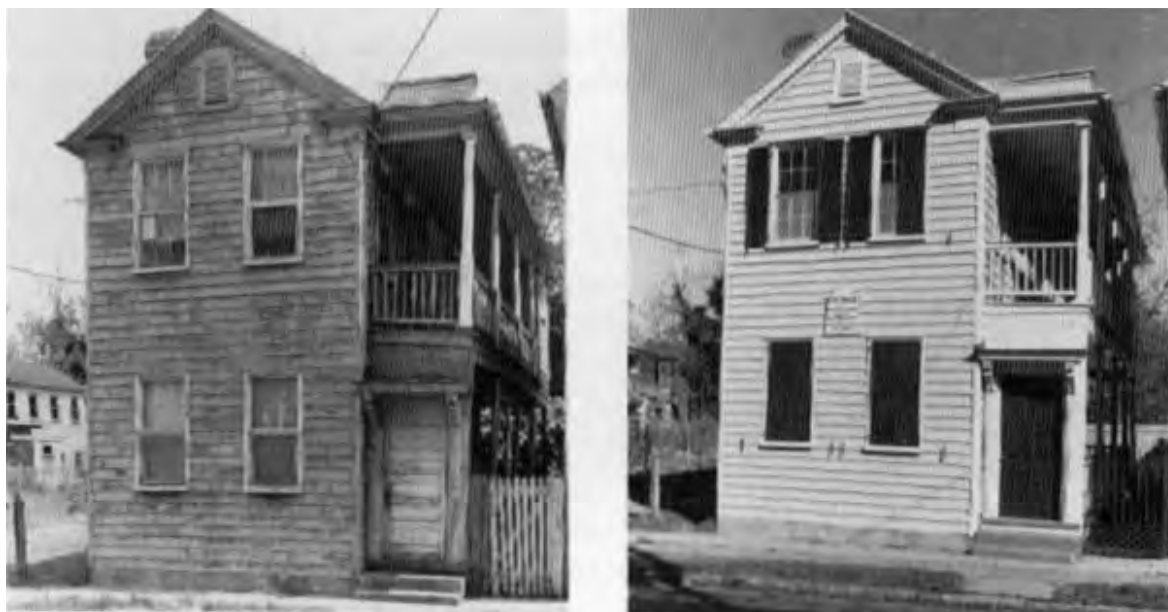
Maximizing retention of historic materials and features is the primary goal of Preservation as demonstrated here in these “before” and “after” photographs. Aside from some minor repairs and limited replacement of deteriorated material, work on this house consisted primarily of repainting the wood exterior. Photos: Historic Charleston Foundation.

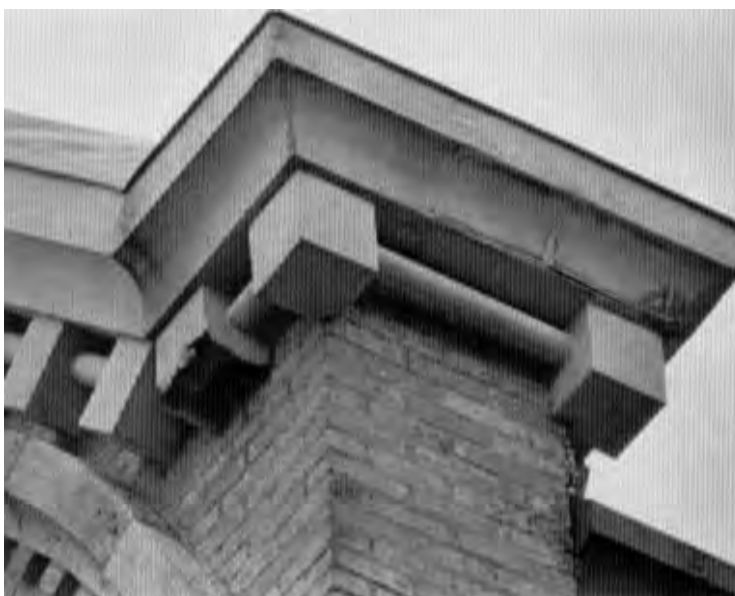
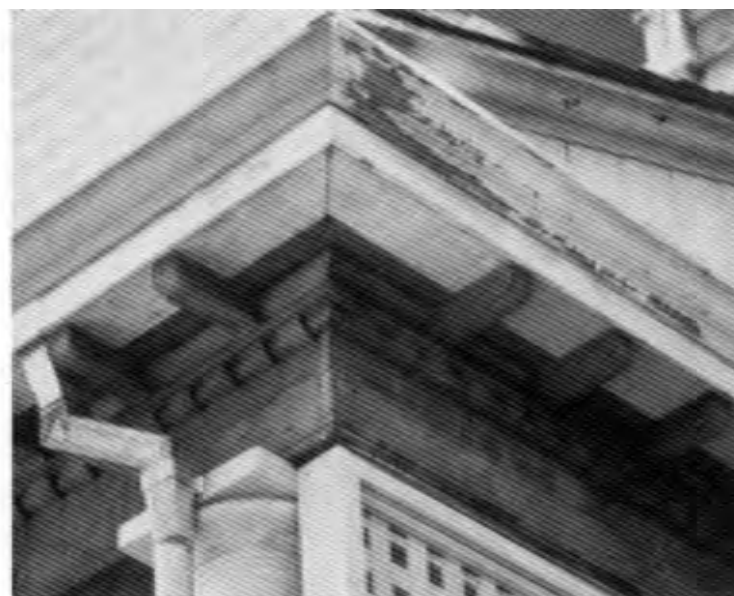
Two examples of “limited replacement in kind” point out an appropriate scope of work within the treatment, Preservation. (a) One metal modillion that has sustained damage from a faulty gutter will need to be replaced; and (b) targeted repairs to deteriorated wood cornice elements (fascia board and modillions) meant that most of the historic materials were retained in the work.

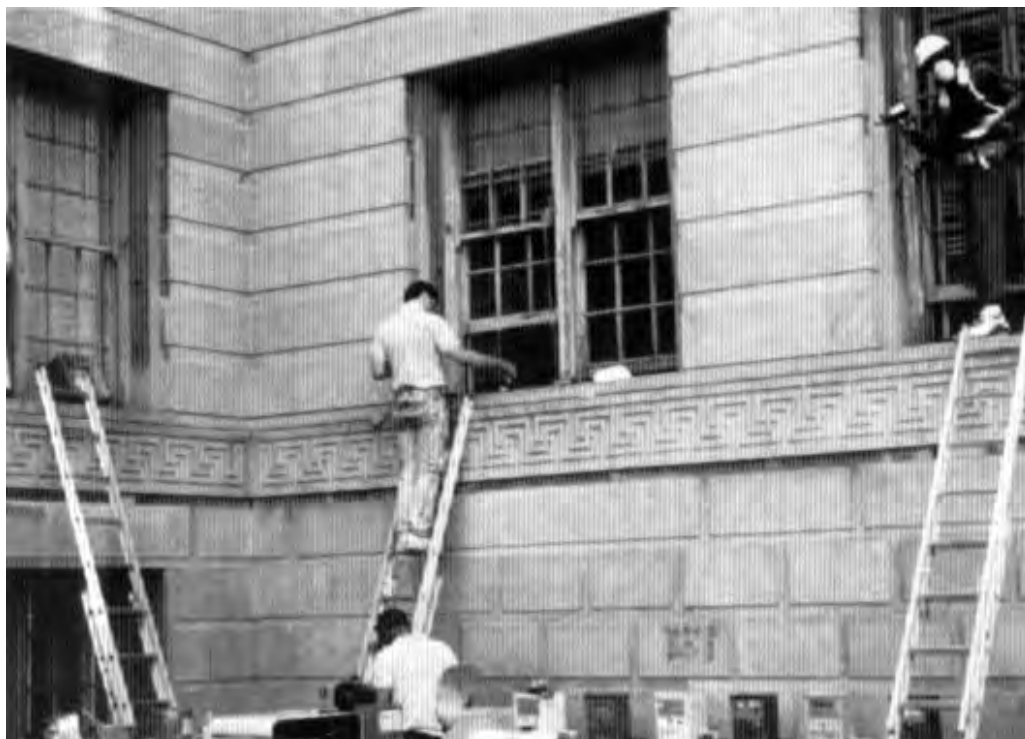
Preserving a building's historic windows generally involves scraping, sanding, and re-painting. While some repair work will most likely be undertaken within the scope of work on this institutional building, replacement of the window units is usually not an appropriate Preservation treatment. Photo: Chuck Fisher.

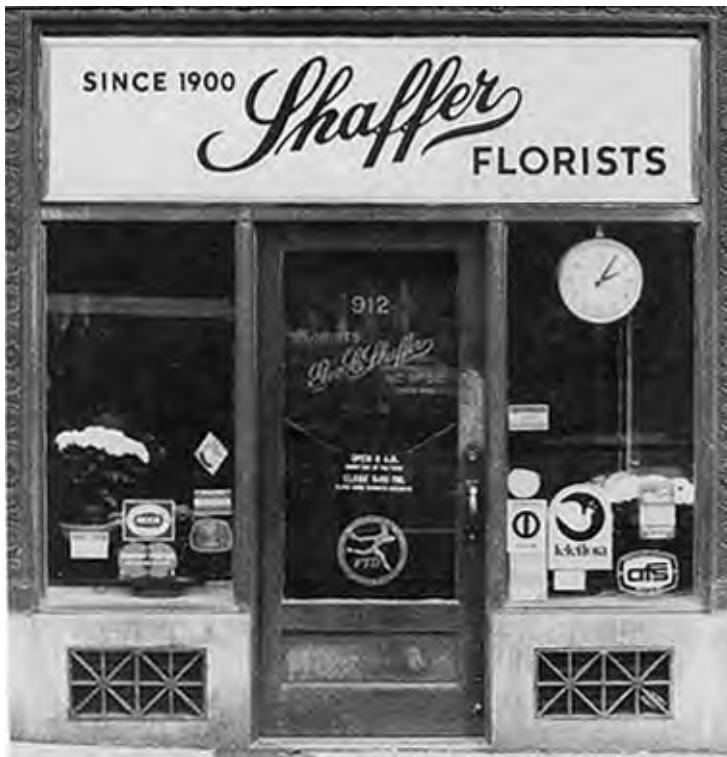
The original form and features of this 1920s storefront have been retained through Preservation. Photo: David W. Look, AIA.

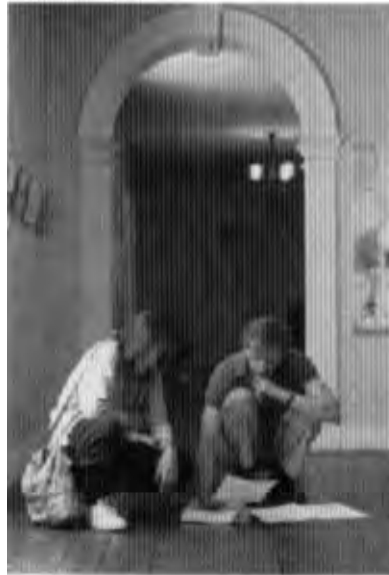
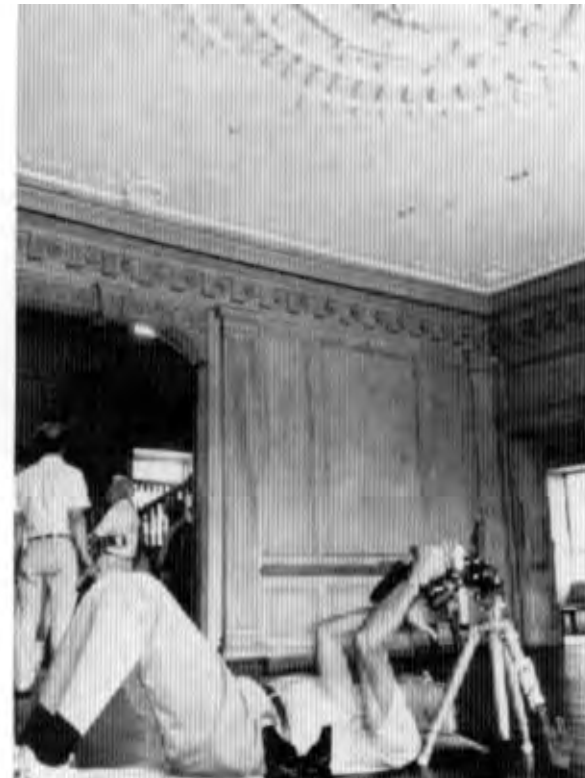
Careful documentation of a building's physical condition is the critical first step in determining an appropriate level of intervention. (a) This may include relating the historical research to existing materials and features; or (b) documenting a particular problem such as this cracked ceiling. Photo (a): Jean E. Travers; Photo (b): Lee H. Nelson, FAIA.

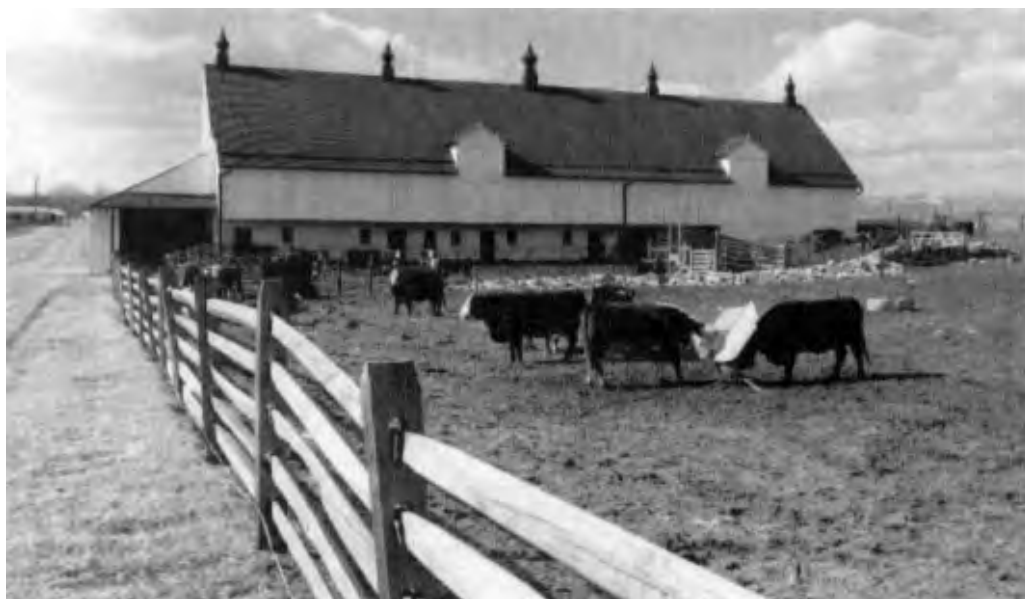
The goal of Preservation is to retain the historic form, materials, and features of the building and its site as they have changed—or evolved—over time. This bank barn was built in the 1820s, then enlarged in 1898 and again in 1914. Today, it continues its role as a working farm structure as a result of sensitive preservation work. This included foundation re-grading; a new gutter system; structural strengthening; and replacement of a severely deteriorated metal roof. Photo: Jack E. Boucher, HABS.

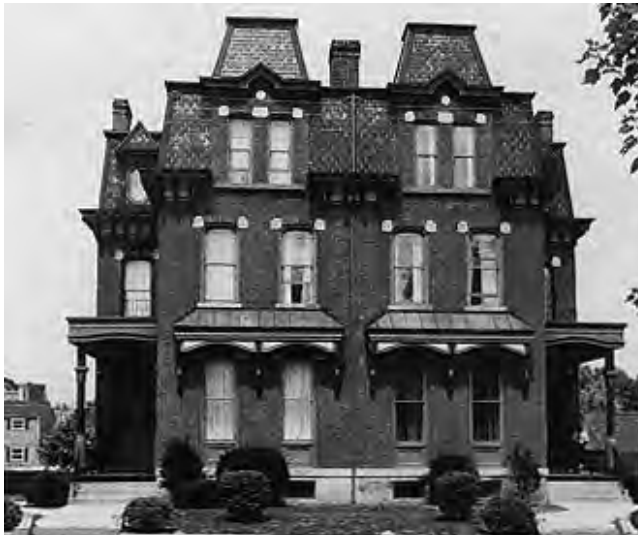
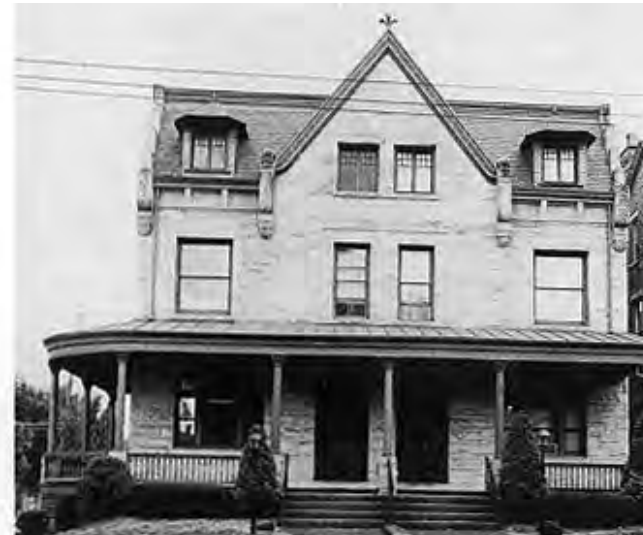
Originally built as single-family, semi-detached duplexes, these houses were rehabilitated for a new use as rental apartments. While some alteration to non-significant interior features and spaces was necessary in each one, the exteriors were essentially preserved. Photos: Mistick, Inc.

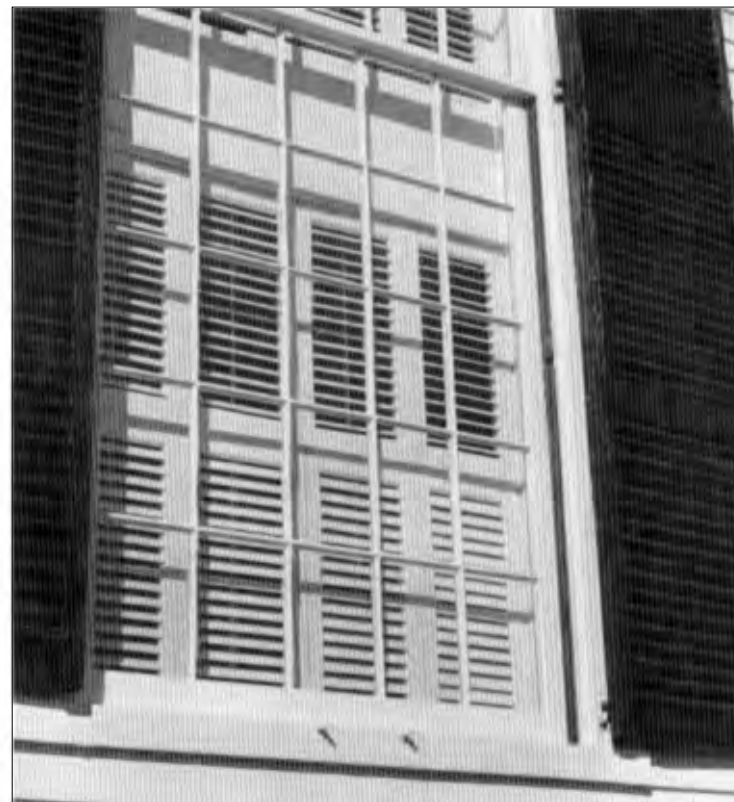
According to the Standards for Rehabilitation, existing historic materials should be protected, maintained and repaired. In an exemplary project, the windows and shutters of this historic residence were carefully preserved.

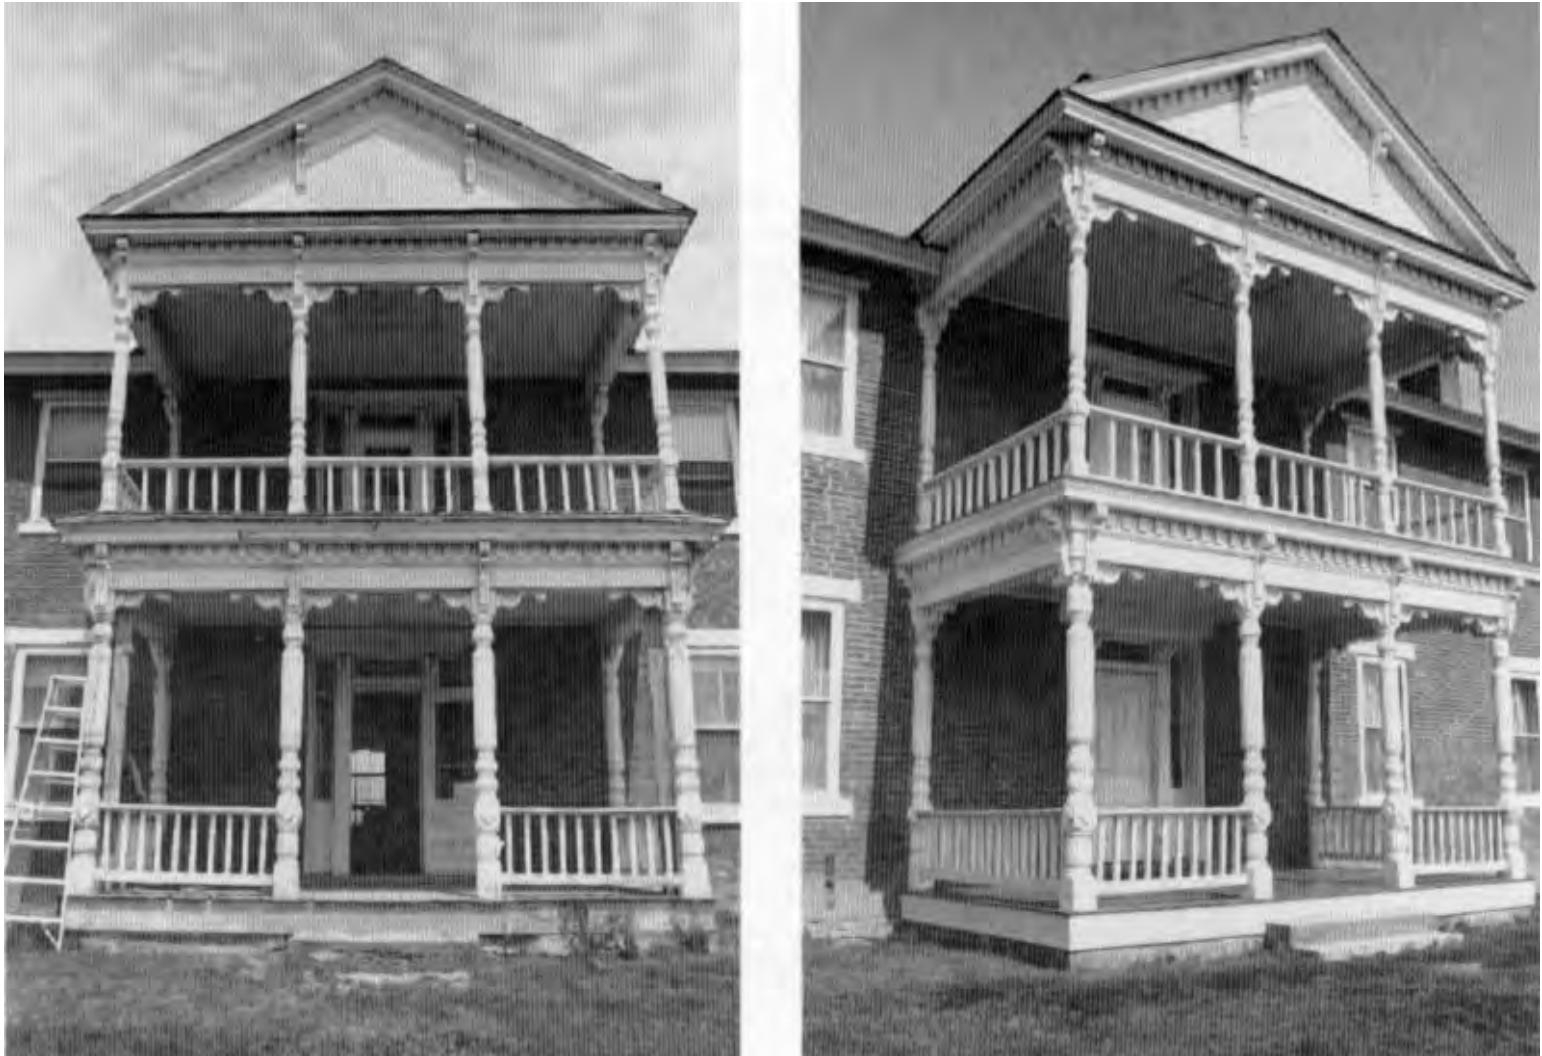
In Rehabilitation, deteriorated features should be repaired, whenever possible, and replaced when the severity of the damage makes it necessary. Here, a two-story porch is seen prior to treatment (left). The floor boards are rotted out and the columns are in a state of collapse, supported only by crude, temporary shafts. Other components are in varying stages of decay. Appropriate work on the historic porch (right) included repairs to the porch rails; and total replacement of the extensively deteriorated columns and floor boards. Some dismantling of the porch was necessary.

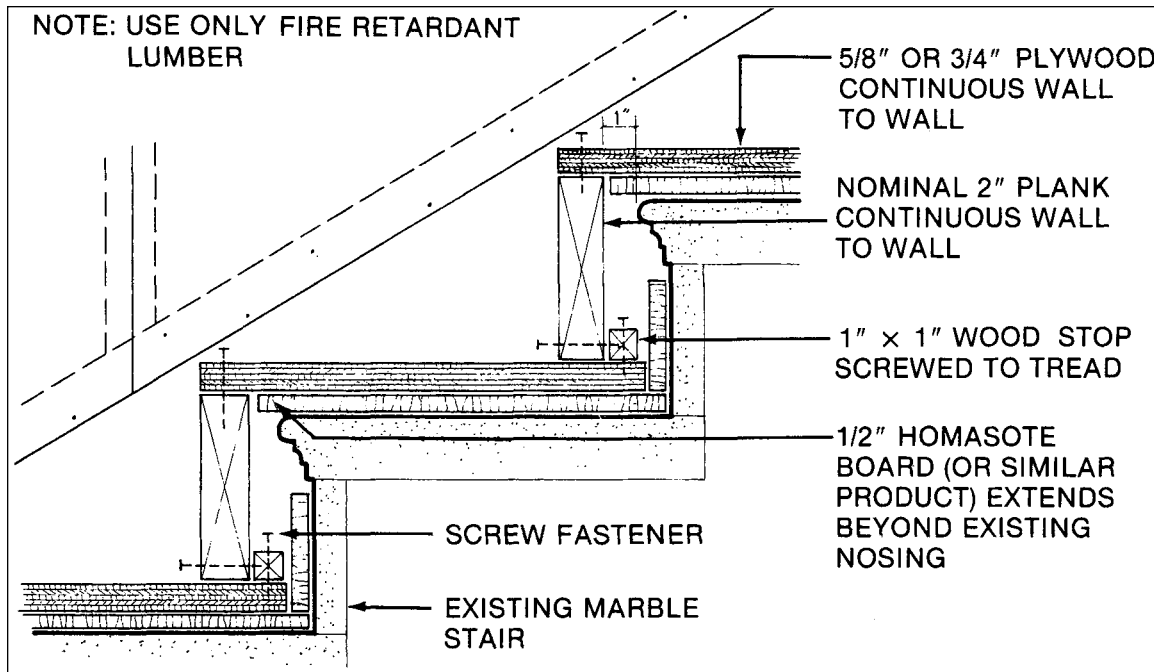
Historic features that characterize a building should always be protected from damage during rehabilitation work. The drawing shows how a resilient, temporary stair covering was applied over the existing marble staircase. Drawing: National Park Service staff, based on material originally prepared by Emery Roth and Sons, P.C.

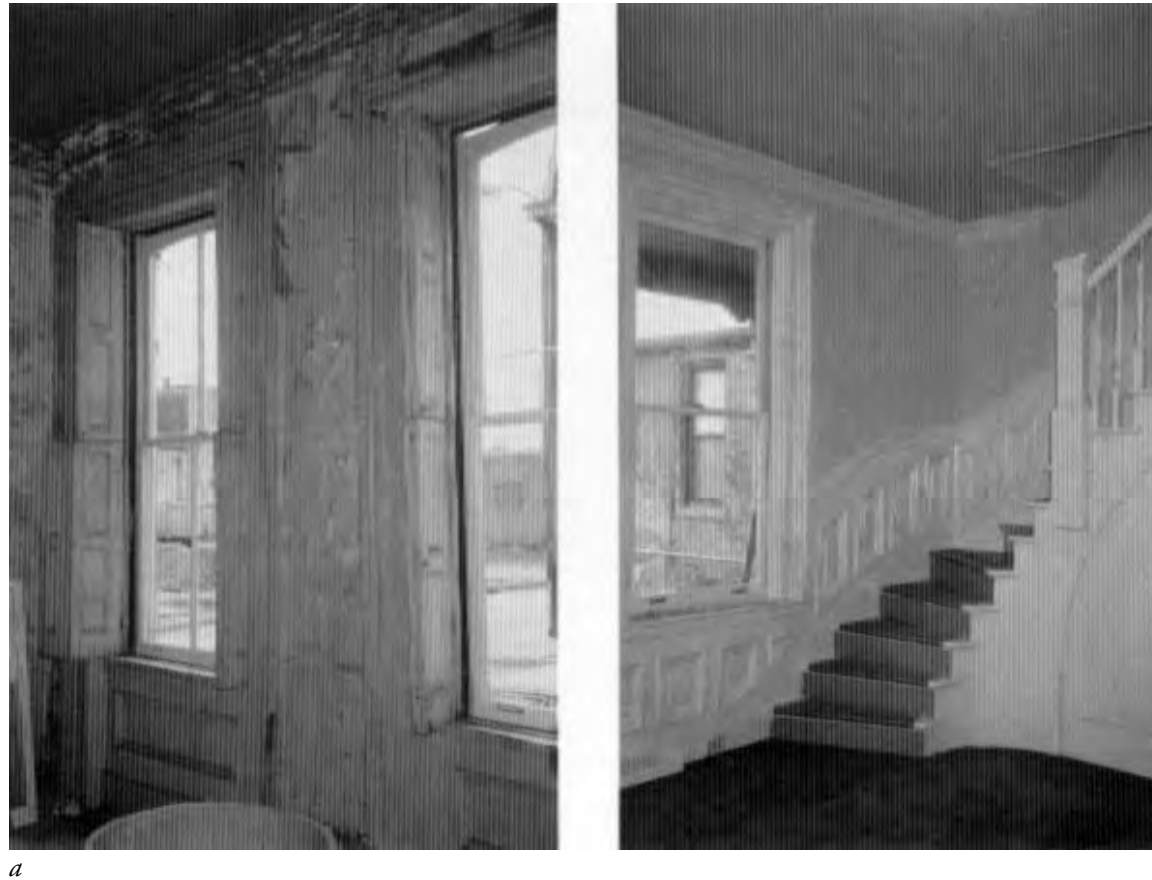
Rehabilitating historic dwelling units often includes some level of lead-paint hazard abatement. Whenever lead-base paint begins to peel, chip, craze, or otherwise comes loose (a), it should be removed in a manner that protects the worker as well as the immediate environment. In this example (b), the deteriorating lead-paint was removed throughout the apartment building and a compatible primer and finish paint applied. Photos: Sharon C. Park, AIA.

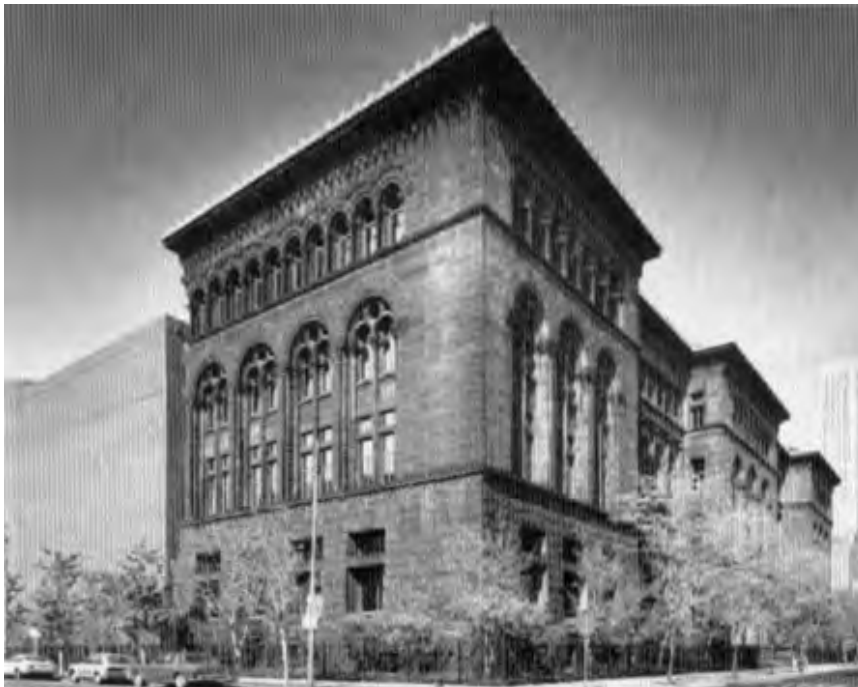
Rehabilitation, like Preservation, acknowledges a building's change over time; the retention and repair of existing historic materials and features is thus always recommended. However, unlike Preservation, the dual goal of Rehabilitation is to—respectfully—add to or alter a building in order to meet new use requirements. This downtown Chicago library was expanded in 1981 when additional space was required with light and humidity control for the rare book collection. The compatible 10-story wing was linked to the historic block on side and rear elevations. Its simple design is compatible with the historic form, features, and detailing; old and new are clearly differentiated. Photo: Dave Clifton.

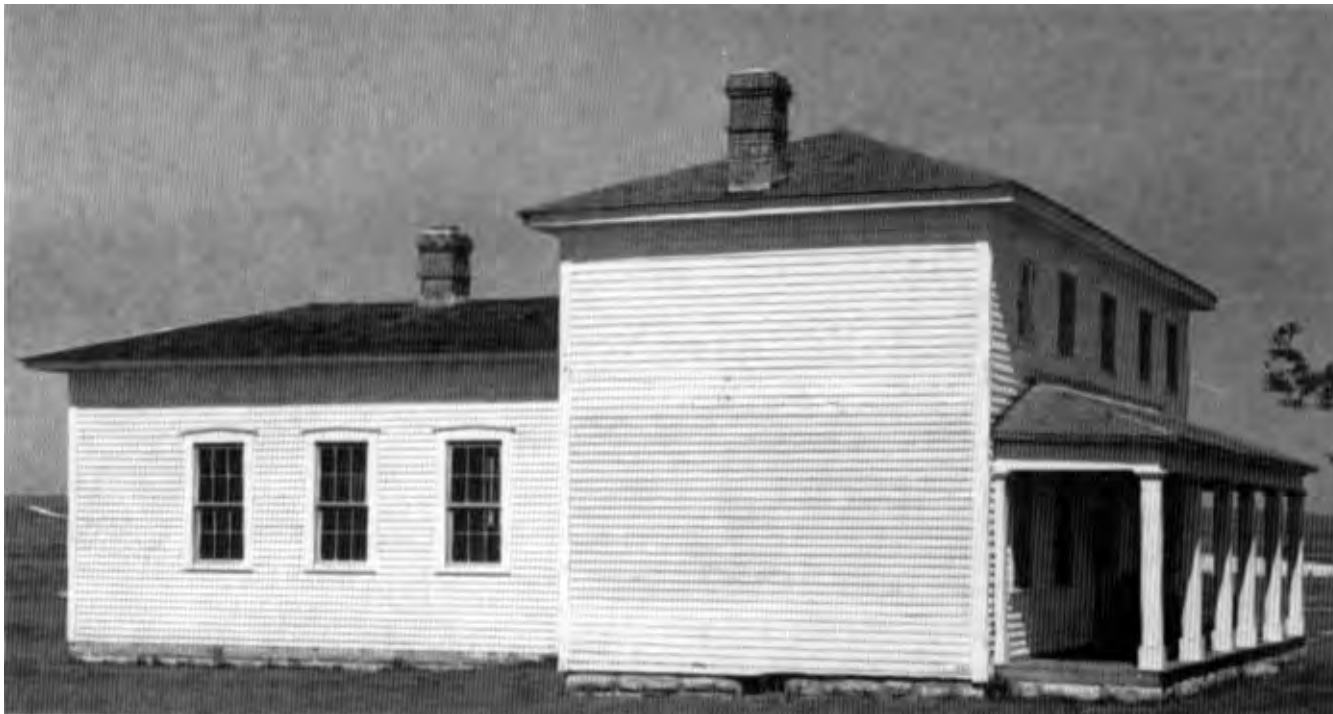
In a project at Fort Hays, Kansas, the wood frame officers' quarters were restored to the late 1860s—their period of significance. This included replacing a missing kitchen ell, chimneys, porch columns, and cornice, and closing a later window opening in the main block. The building and others in the museum complex is used to interpret frontier history.

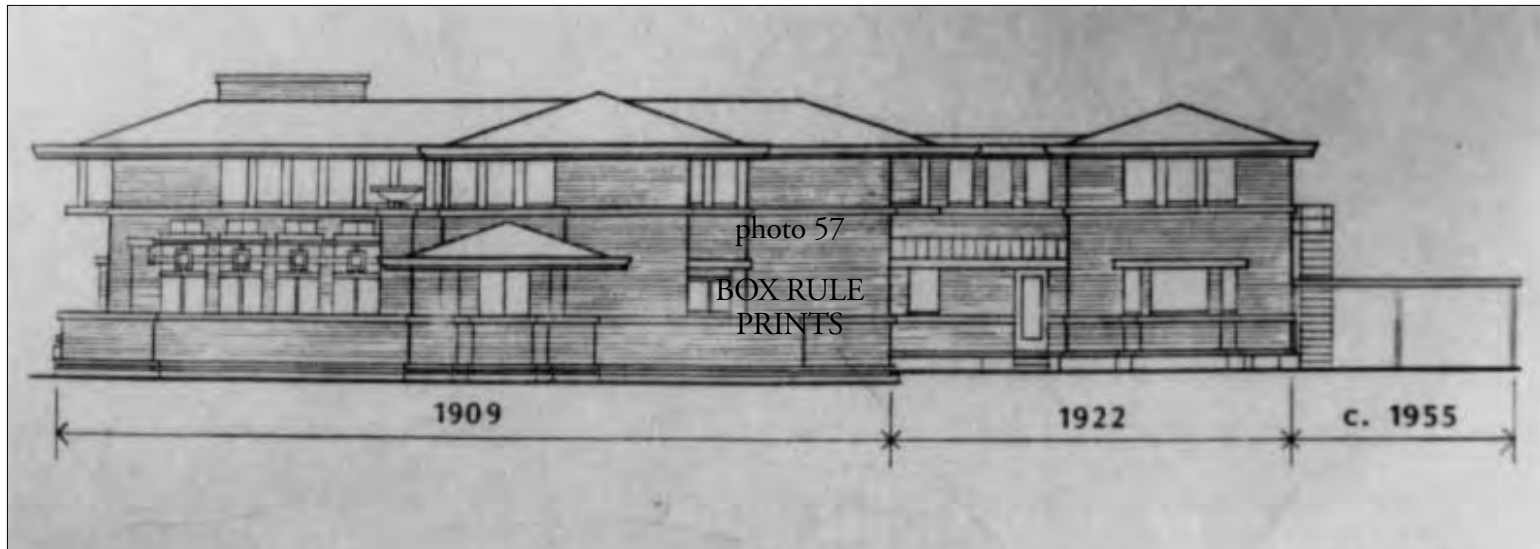
The Meyer May House in Grand Rapids, Michigan, was designed by Frank Lloyd Wright and built in 1909. In 1922, May added to the house for an expanding family. After the May occupancy, the house was altered for use as apartments, with a carport added in 1955. In the 1980s restoration, the Wright's original design was deemed more significant than May's later changes, and, as a result, the additions were removed and the house returned to its 1909 appearance. Drawing: Martha L. Werenfels, AIA.

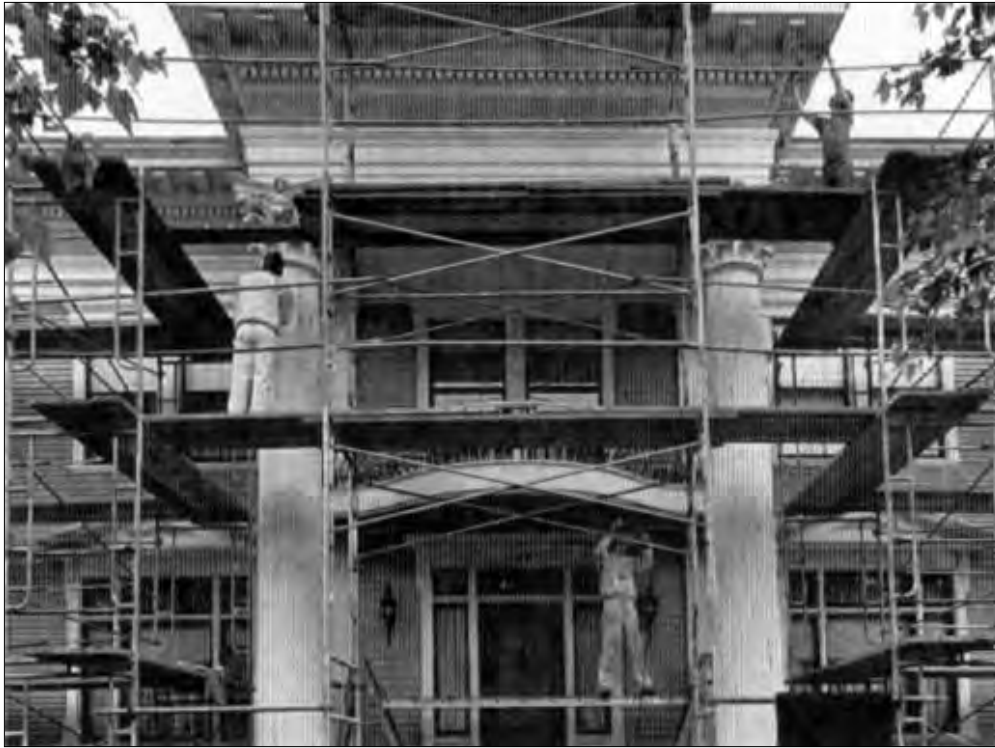
Ongoing work at this house focuses on the maintenance and repair of exterior wood features from the restoration period. After scraping and sanding, the wood was painted in colors documented to the Restoration period. Photo: ©Mary Randlett, 1992.

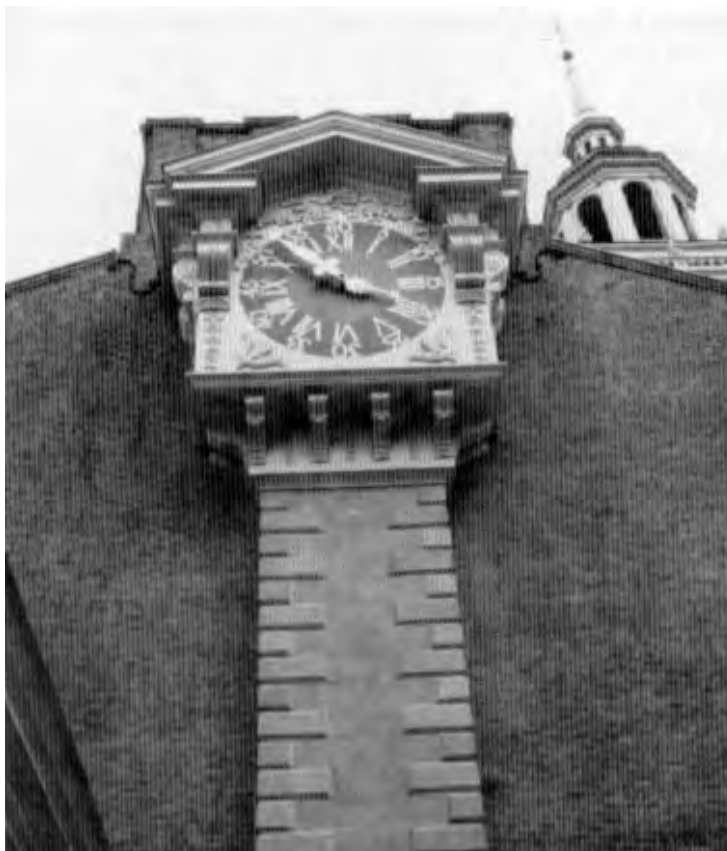
The Standards for Restoration call for the repair of existing features from the restoration period as well as the re-creation of missing features from the period. In some instances, when missing features are replaced, substitute materials may be considered if they convey the appearance of the historic materials. In this example at Philadelphia's Independence Hall, the clock was re-built in 1972-73 using cast stone and wood with fiberglass and polyester bronze ornamentation. Photo: Lee H. Nelson, FAIA.

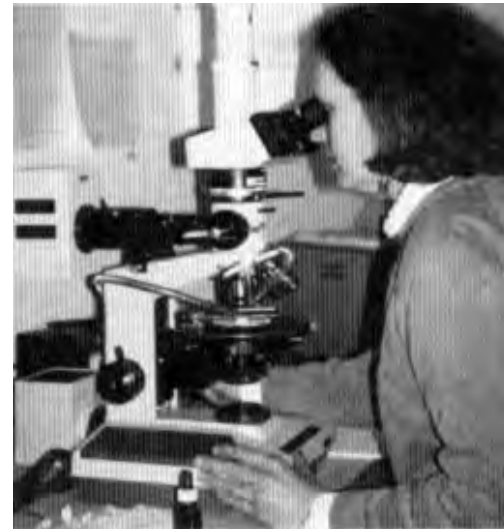
A complete paint investigation often needs to be conducted during Restoration. Paint samples are carefully collected onsite. In the laboratory, an ultra violet light is used to identify pigment and binding media. Paint samples are then photographed. Physical evidence documented through laboratory research provides a sound basis for an accurate restoration of painted finishes, such as the complex stencilling pictured here. Photo left: Courtesy, Alexis Elza; Photo right: Courtesy, Andrea Gilmore.

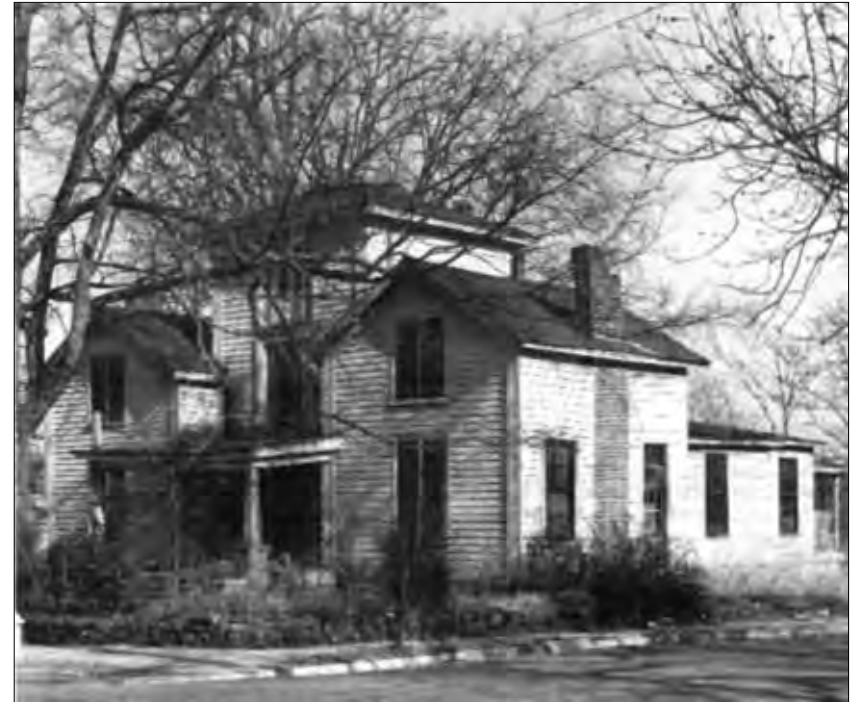
This ca. 1900 photograph (left) would be invaluable to guide restoration of the deteriorated house (right) to its documented earlier appearance, complete with decorative trim, shutters, polychromed exterior, and fencing. Photos: Courtesy, North Carolina Department of Archives and History.

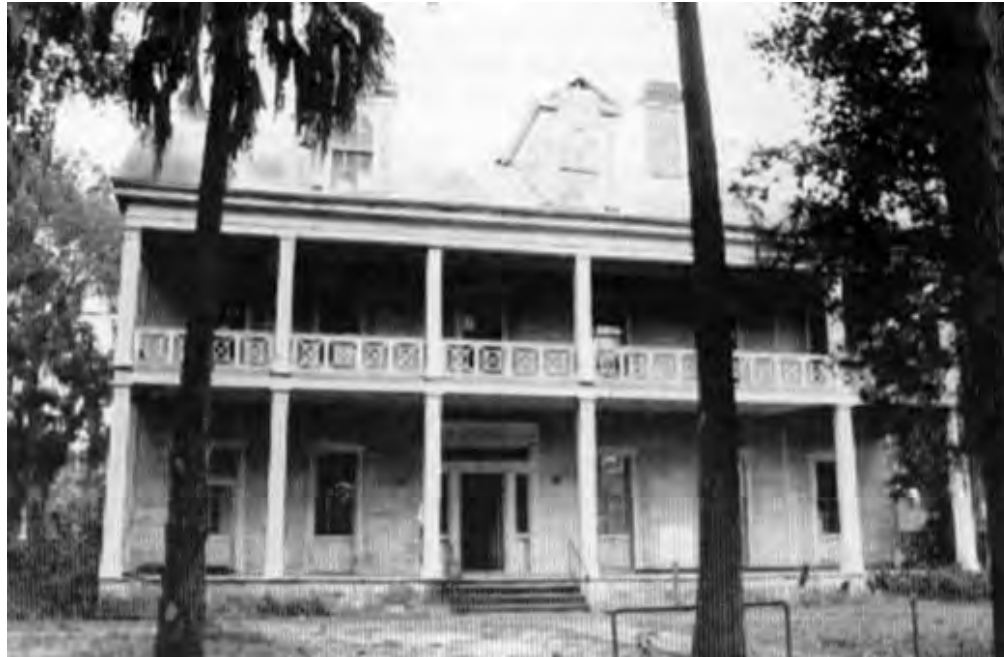
The Bronson-Mulholland House in Palatka, Florida, ca. 1845, is shown (a) before and (b) after the treatment, Restoration. Over the years the east (far right) side of the veranda had been filled in as a sixth bay. During the restoration, this later infill was removed and the east veranda, together with its flooring, stairs, and foundation, restored. Photo: City of Palatka, Community Development Department.

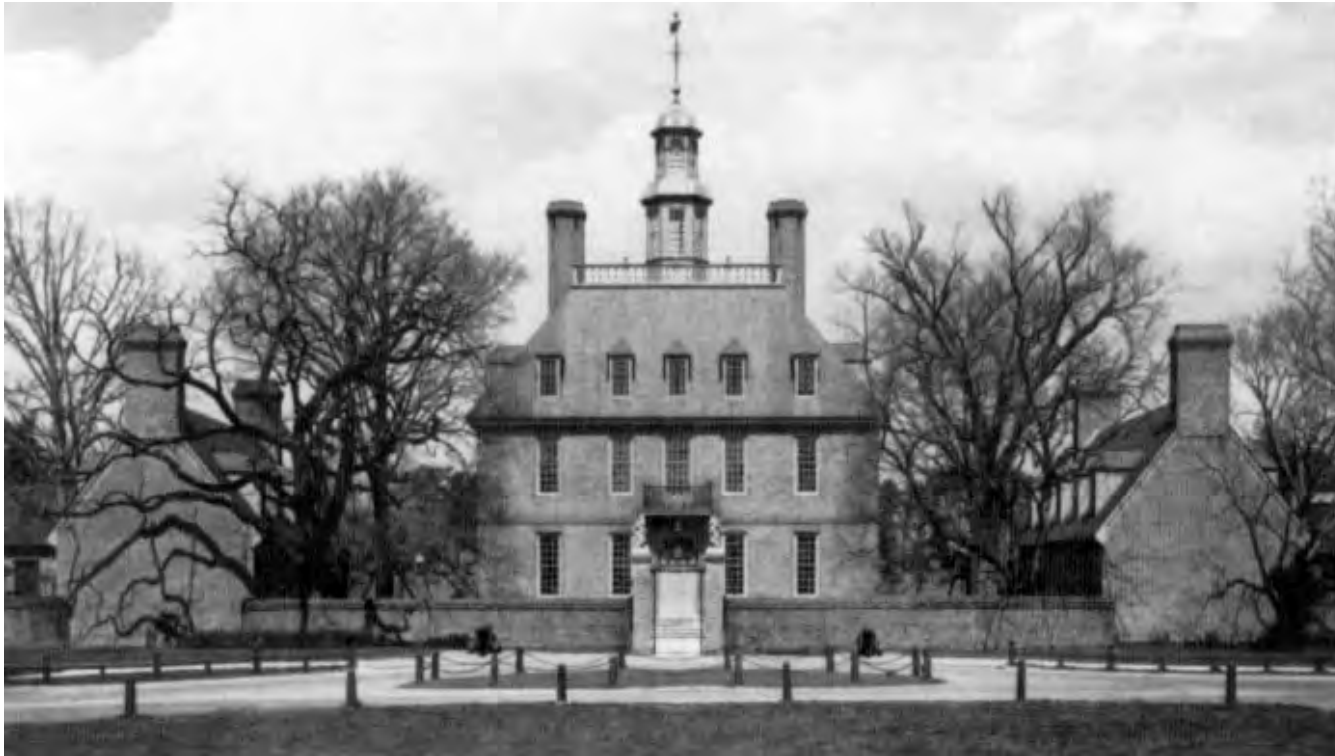
*In the 1930s reconstruction of the 18th century Governor's Palace at Colonial Williamsburg, Virginia, the archeological remains of the brick foundation were carefully preserved in situ, and serve as a base for the reconstructed walls.
Photo: The Colonial Williamsburg Foundation.*

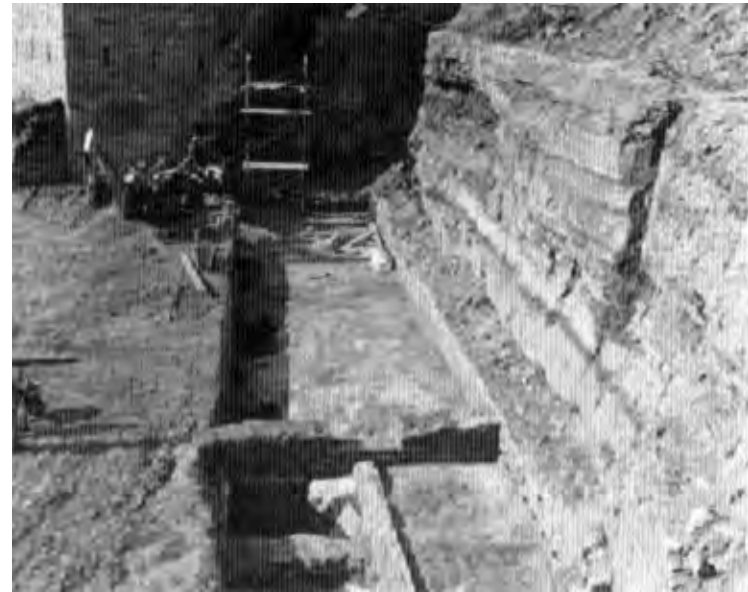
Reconstruction should generally be based on an extensive archeological investigation, as was done here to re-create a non-surviving commissary building at Fort Snelling.

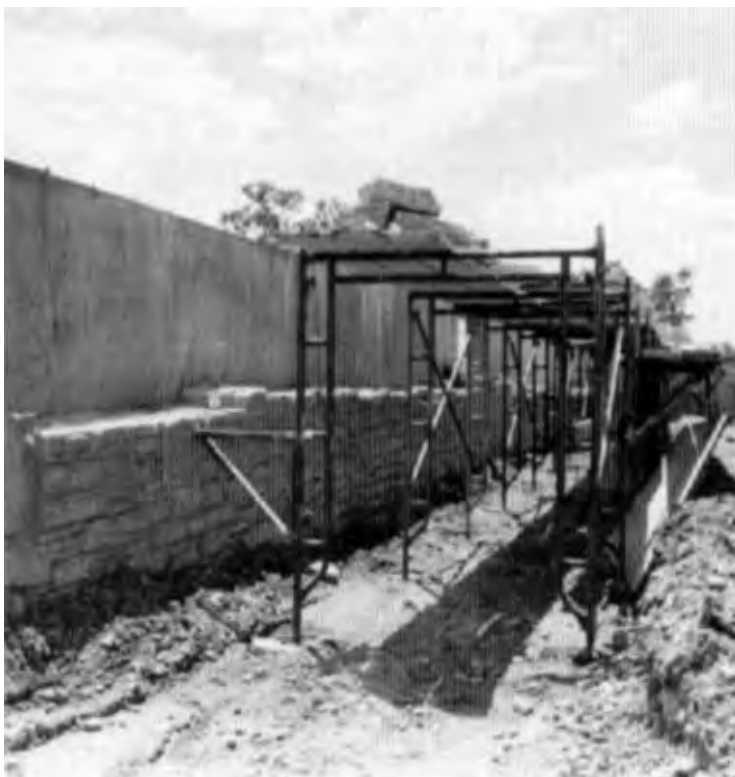
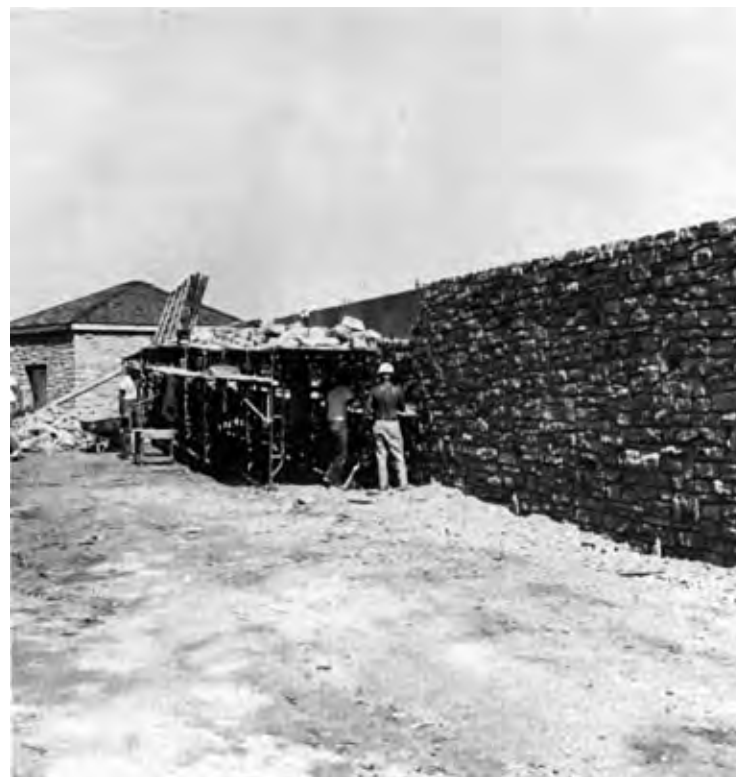
(a) and (b). Two photos illustrate the use of contemporary construction materials and techniques within the treatment, Reconstruction. Because Reconstruction is employed to portray a significant earlier time, usually for interpretive purposes, substitute materials may be appropriate if they are able to convey the historic appearance.

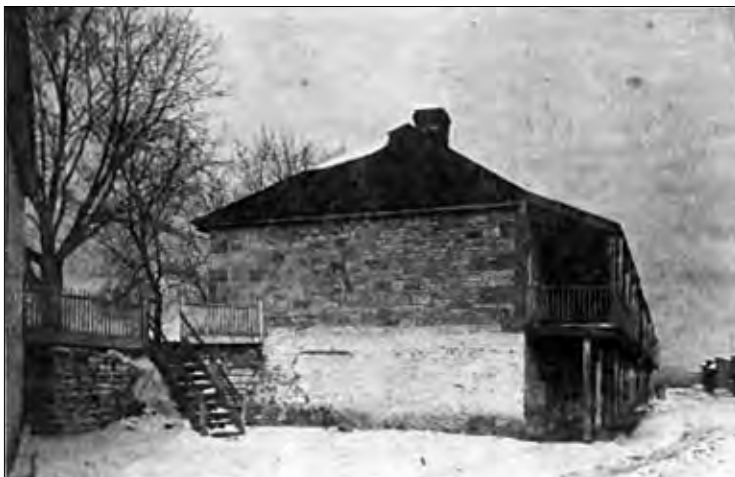
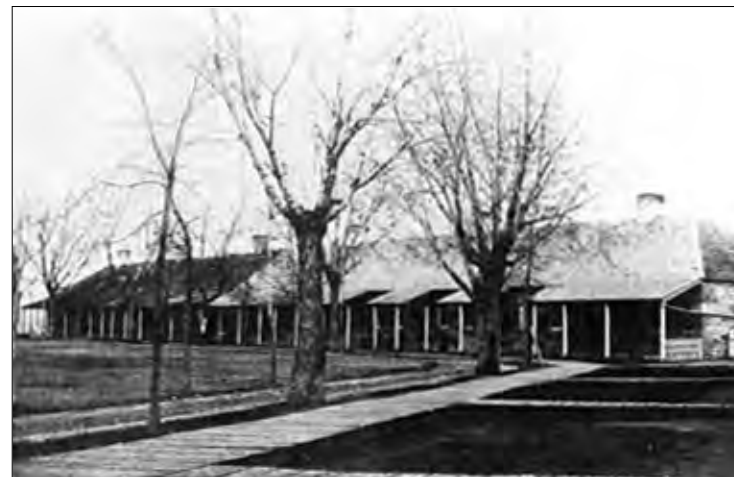
(a) and (b). Two views of the Officers' Quarters at Fort Snelling (ca. 1885 to 1900) not only provide information on the materials and form of the historic block, they document the wooden walkways and other landscape features such as stairs, railings, and tree placement. Historical and pictorial evidence would need to be combined with specific physical evidence in order to make the case for Reconstruction as a treatment.

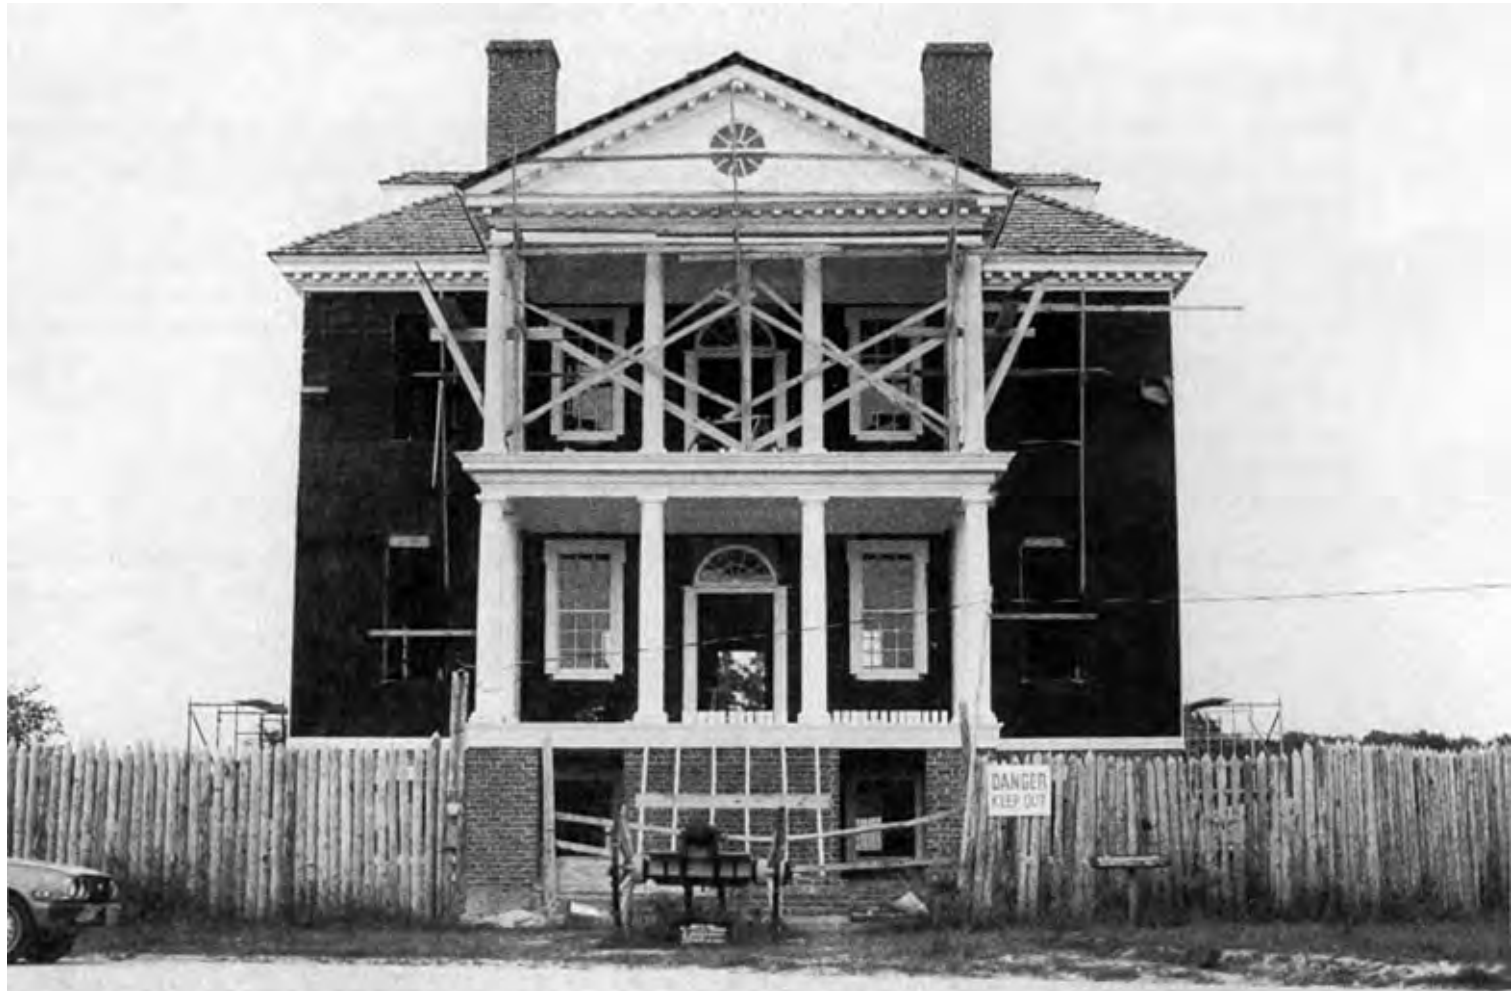
The 1778 Kershaw House, which served as British Headquarters during the Revolutionary War, was burned by Union troops in 1865. In the early 1970s, the house was reconstructed as part of Camden Battlefield, Camden, South Carolina. Built expressly for interpretive purposes, it serves as an illustrative reminder of a past event of national significance. The Standards for Reconstruction call for any re-created building to be clearly identified as a contemporary depiction. This is most often done by means of an exterior sign or plaque, or through an explanatory brochure or exhibit. A guide may inform visitors as well. Photo: Richard Frear.
